Reference No. 1314210002-003-L-Rev0

## **KINGSTON INNER HARBOUR – SOURCE INVESTIGATION FOR SOUTHWEST TRANSPORT CANADA WATER LOT**

PWGSC  
KINGSTON INNER HARBOUR  
KINGSTON, ONTARIO

TOTAL PAH BULK SEDIMENT CHEMISTRY AND  
INVERSE WEIGHTED DISTANCE SURFACE (2003-2012)

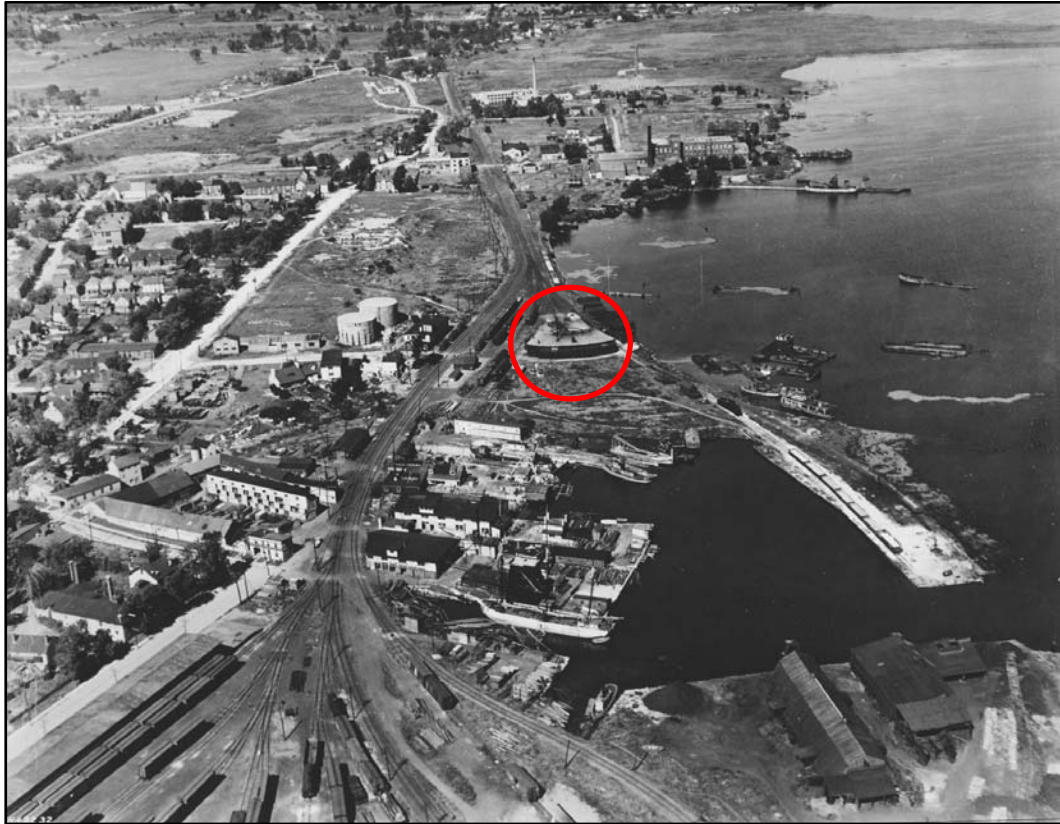
*Photograph 1: Aerial photograph looking north showing Kingston Inner Harbour with the rail yard in the foreground and the roundhouse (circled in red) in the middle of the photo (c. 1924).*

The waterfront near Anglin Bay served as a large rail yard for the Canadian National and Canadian Pacific railways (**Photograph 1**). The Canadian Pacific Railways built a four stall roundhouse at the foot of North Street (now part of Douglas Fluhrer Park) which served the rail yards (**Photograph 2**). The rail yard and roundhouse were located adjacent to the portions of the TC water lot that currently contain the highest PAH concentrations.

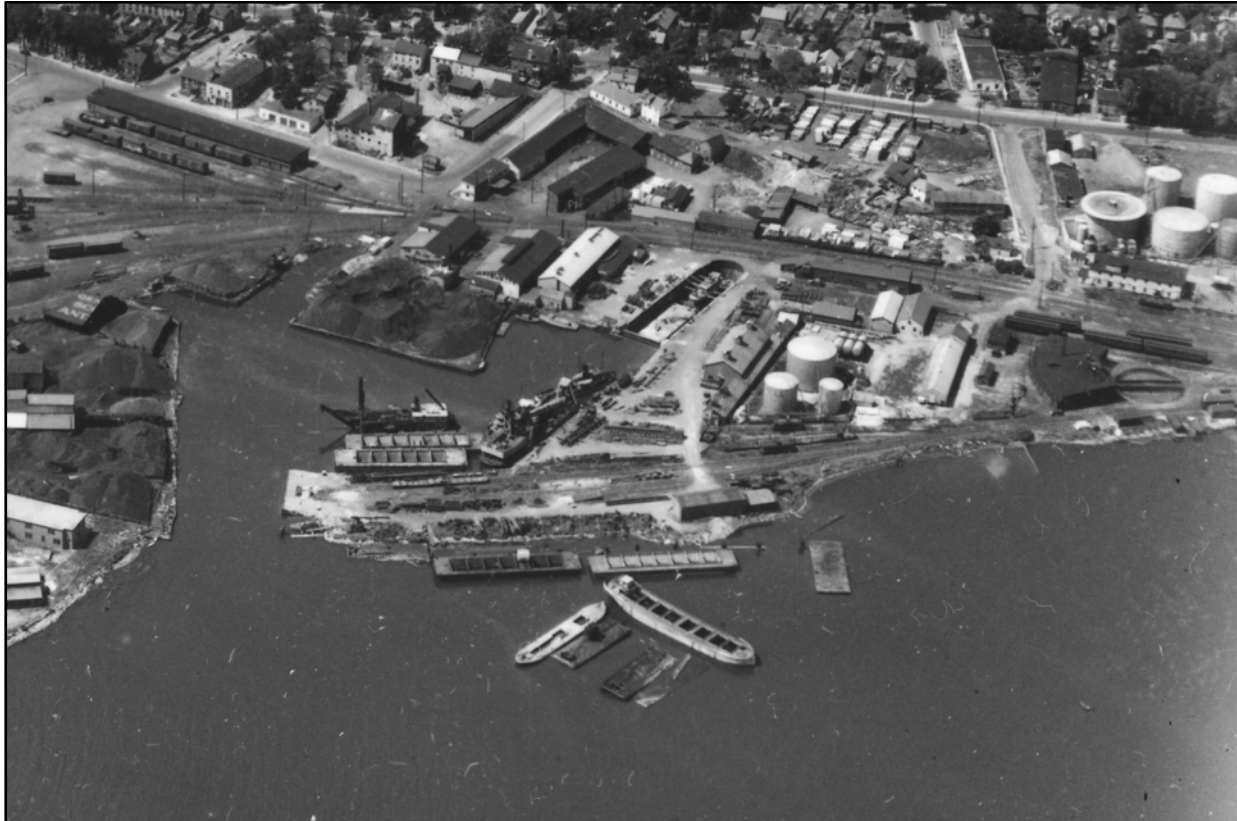
*Photograph 2: Aerial photograph looking west showing large coal piles surrounding Anglin Bay, bulk fuel storage facilities (center right and top right), the edge of the rail yard to the left and the roundhouse to the right (c. 1951).*

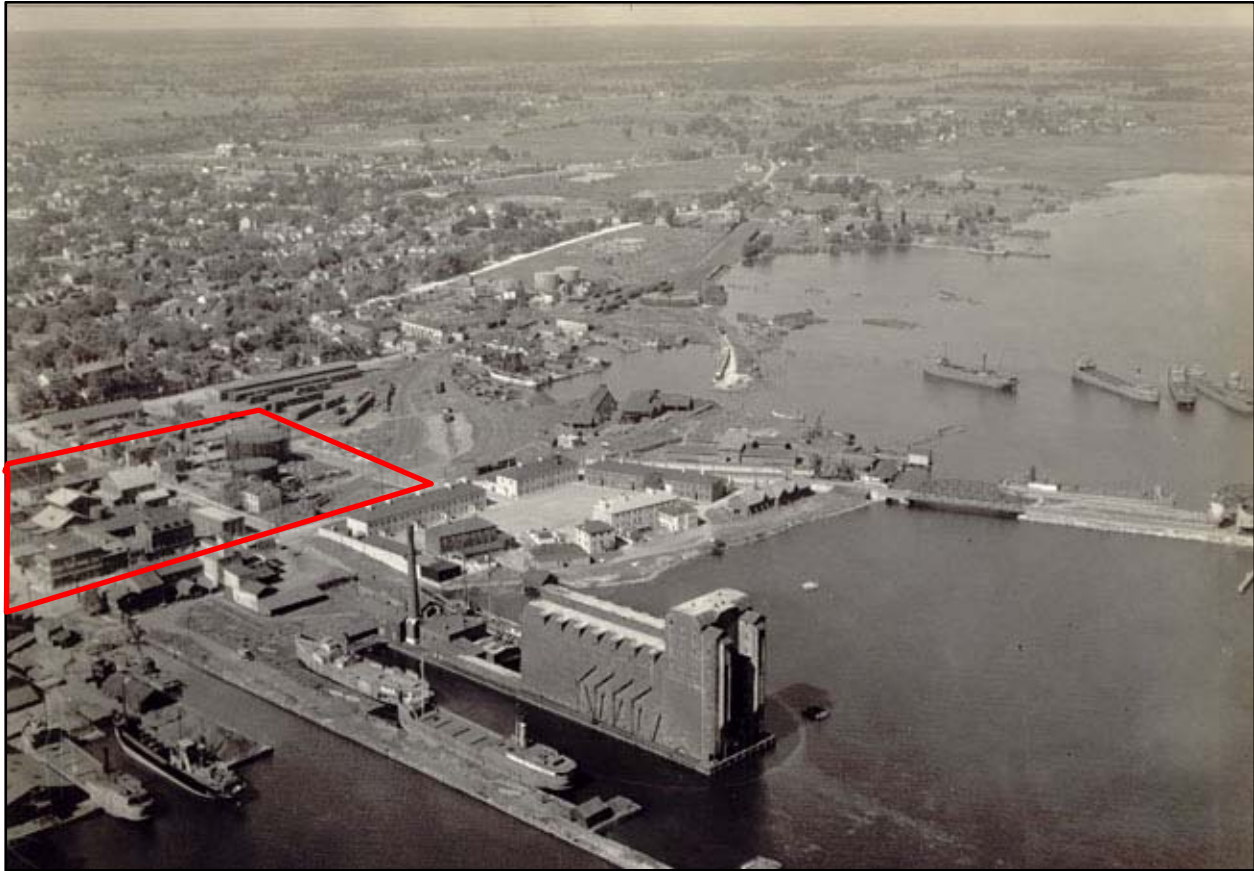
*Photograph 3: Aerial photograph looking northwest showing Kingston Inner Harbour with coal gasification plan (highlighted in red; c. 1925).*

A large coal gasification plant operated in the City of Kingston southwest of Anglin Bay from 1848 to the early 1950s (**Photograph 3**). The plant's principal function was to carbonize coal and oil to produce gas. A by-product of the gas extraction process was a thick black coal tar, some of which was used as a preservative for railway ties (CH2M Hill 1991). It is suspected that improperly managed coal tar may be a potential source of the PAH contamination in the KIH sediments within the area; however, contamination from this source does not explain the spatial extent of PAH contamination observed.

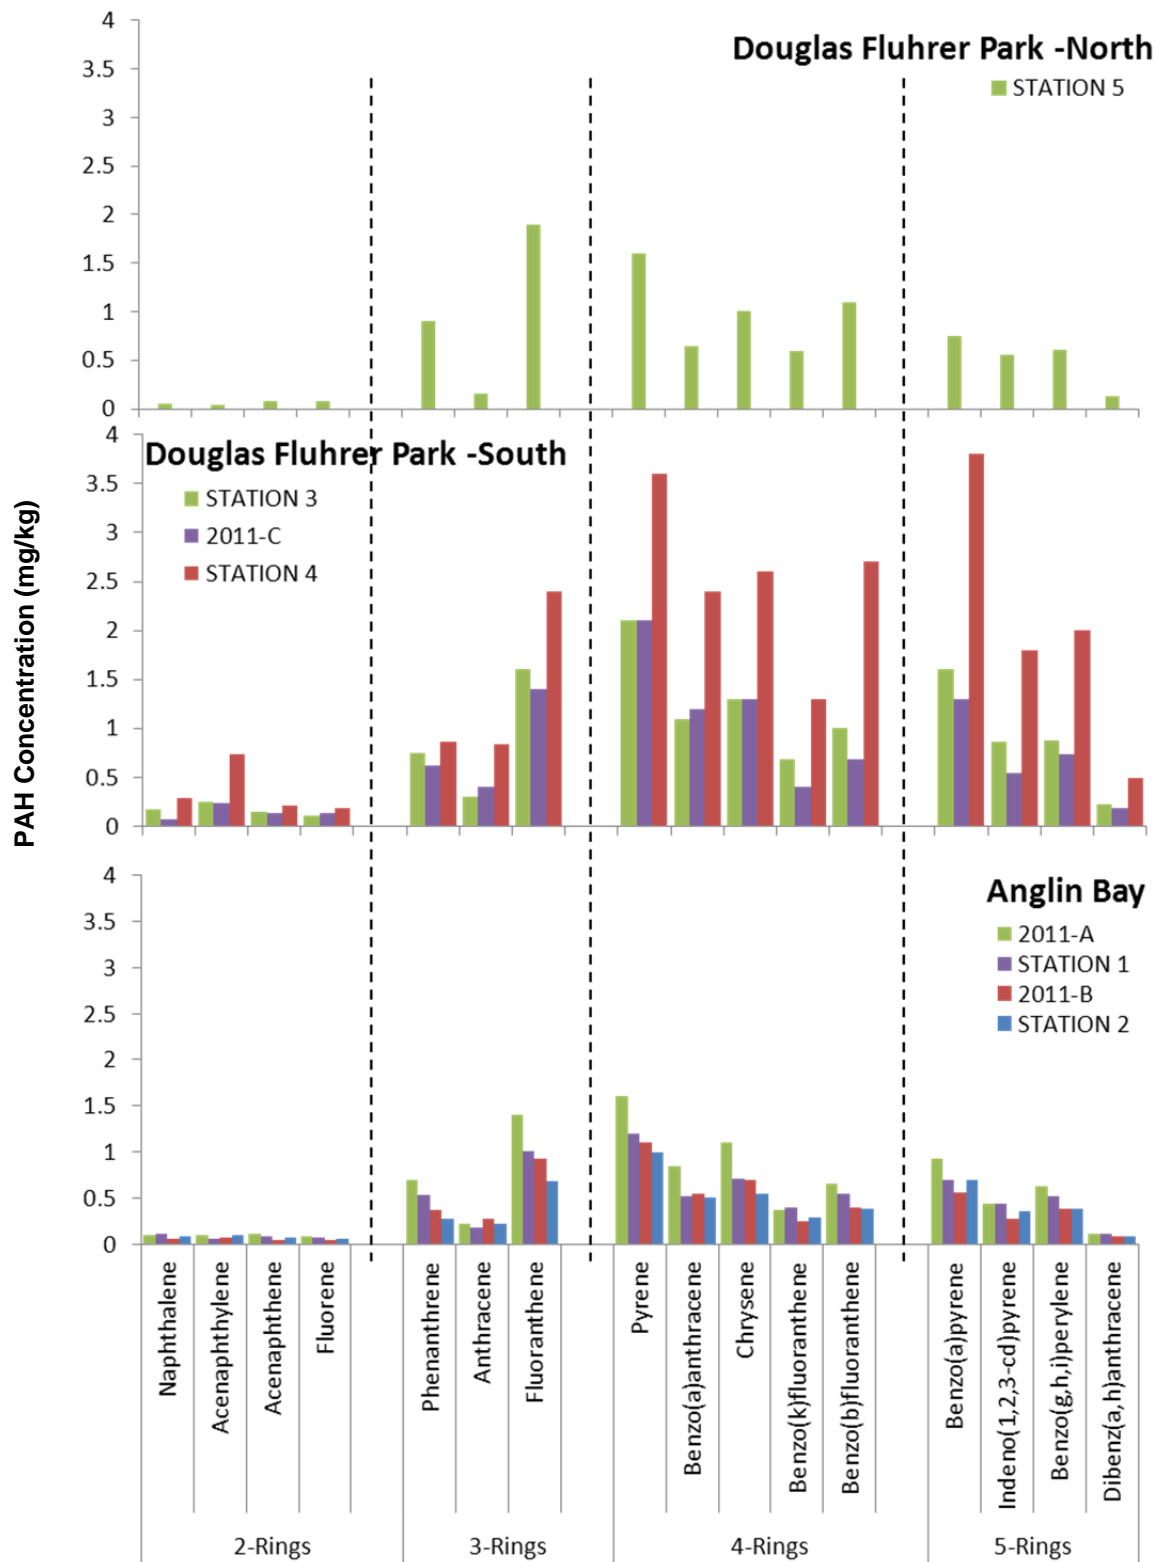
FIGURE 2

Figure 2: Distribution of PAHs with Douglas Fluhrer Park North and South Sediment and Anglin.

Sediment PAH distributions of KIH sediment within the areas of interest tend to have higher concentrations of four and five-ringed PAHs as compared two and three ringed PAHs (**Figure 2**). The phenanthrene/anthracene ratio of sediment at stations closest to the shoreline (Anglin Bay Stations 2011-A and Station 1; Douglas Fluhrer Park-South Station 3; Douglas Fluhrer Park-South Station 5) range from 2.5 to 5.6. Using the diagnostic ratios from Abrajano *et al.* 2003 these data are indicative of PAHs of pyrogenic origin. The phenanthrene/anthracene ratio is somewhat reduced at stations further from the shoreline to ratios between 1.2 and 1.6; **Table 2**). The fluoranthene/pyrene ratios for most sites were less than one; however, because degradation and/or re-partitioning may result in significant post-depositional changes in 2 and 3-ring PAH compounds, benzo(a)anthracene/chrysene ratios considered a more useful indicator (McCready *et al.* 2000; Depree and Ahrens 2003). Benzo(a)anthracene/chrysene ratios were between 0.6 and 0.9 for all sites, suggesting either a pyrogenic or mixed source of PAHs. Overall, the evidence indicates that PAHs in sediment are mainly the result of pyrogenic sources.
